BTS BUILDING & CONSULTING Pty Ltd

Building Completion Inspection Report

(In accordance with AS4349.1 2007 'Inspection of Buildings')

Sample NSW 2570

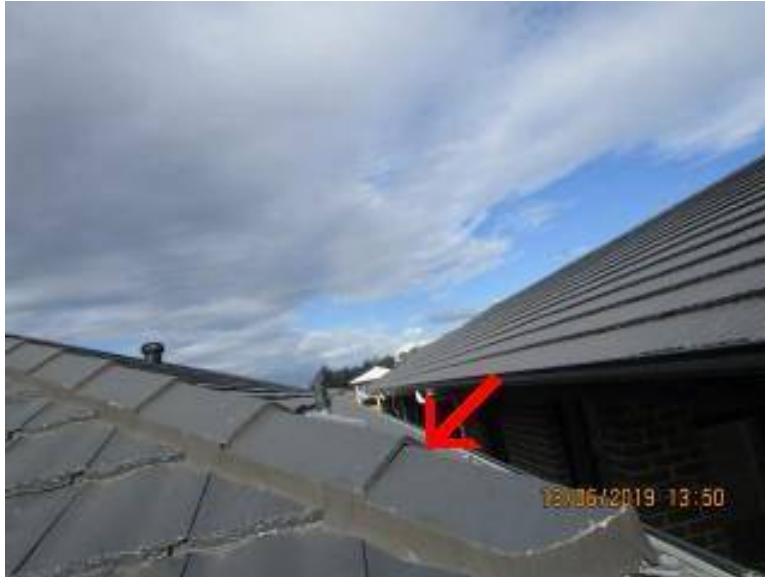
The overall condition of the roof coverings is fair. The External Roof System should be regularly inspected for damage and defects which may allow rain water penetration. The mortar bed to the ridge capping is cracked or missing which may allow rainwater penetration and requires re bedding and pointing. This is considered to be a major defect.

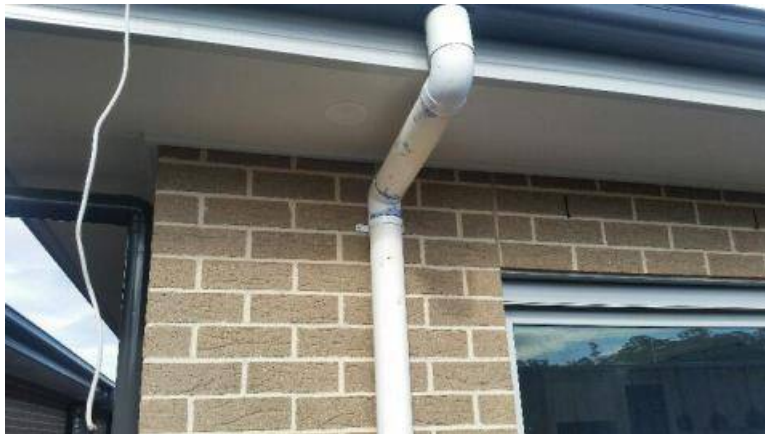
Downpipes appear to be connected to the stormwater dispersal system, however, correct connection can only be confirmed with a smoke test.

Downpipes require painting for an acceptable finish.

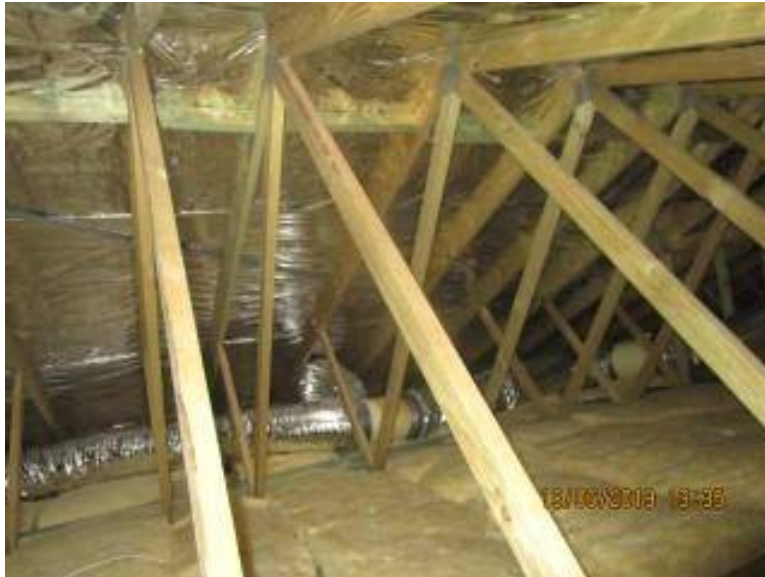
The timber truss roof system is adequate for the roof covering.

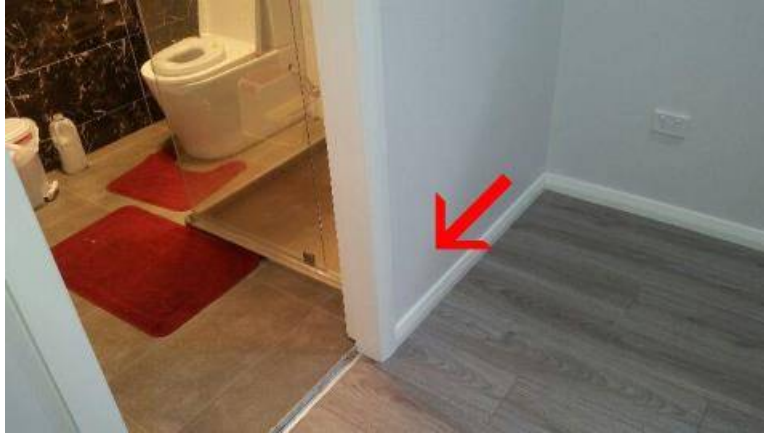
The condition of the walls is generally fair. A higher than average moisture reading was noted to walls adjacent to wet areas in the bathroom. This is an indicator that a shower leak or other free moisture source is present and should be further investigated. If the waterproof membrane of the shower has broken down, this will require replacing.

A qualified Leak Detection Expert should be engaged for further investigation and diagnosis.

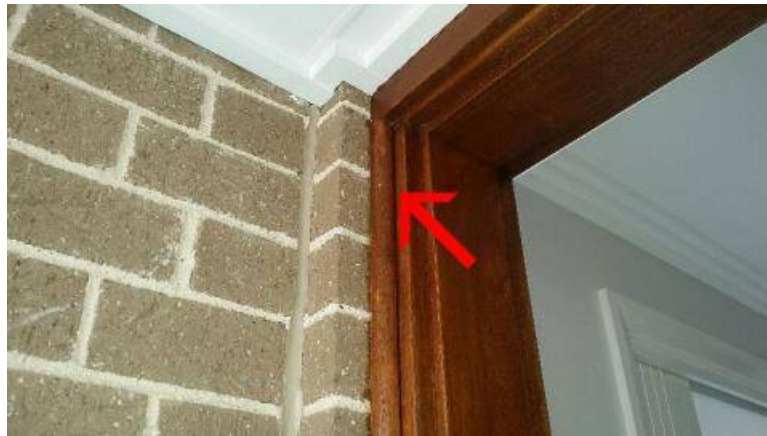
The condition of the woodwork is generally fair. Timber trims are loose and will require securing.

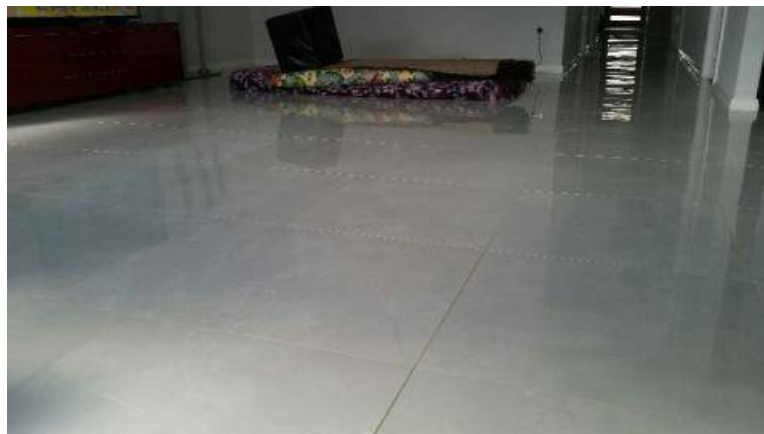
Tiling is defective if the lippage between two adjacent tiles exceeds 2 mm. In the case of tiles where the surface has been ground flat, for example polished tiles, tiling is defective if the lippage exceeds 1.5 mm; for joint widths of 3 mm or less the lippage should not exceed 1 mm. We noted during our inspection that lippage appears to exceed the requirements of AS 3958.1 and AS 3958.2 or the manufacturers installation instructions for the materials selected. Floor tile joints are uneven, not uniform, of an even width and surface joints are not flush, rectification is required for an acceptable finish.

The condition of the floors is generally fair. The condition of the floors is generally fair. Floor tile joints are uneven and surface joints are not flush, rectification is required for an acceptable finish. (See General Section of the Report)

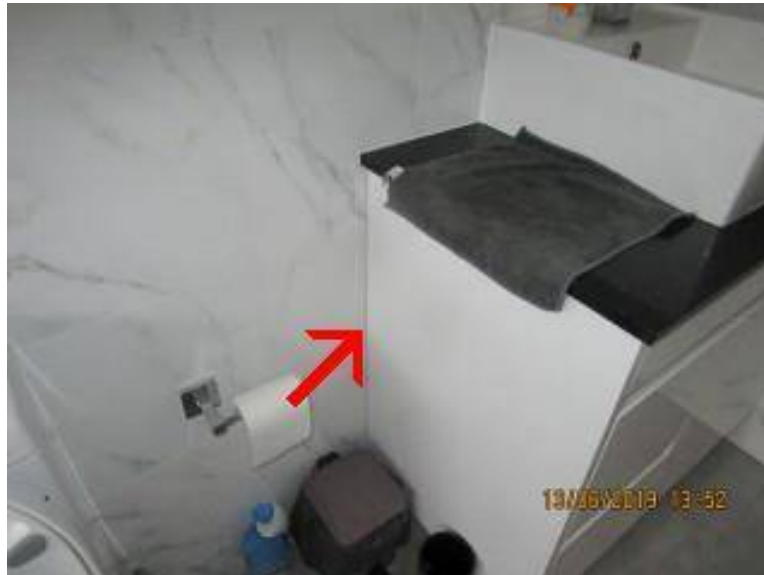
The condition of the vanity unit is generally fair. Flexible sealant is required to joinery and wall junction.

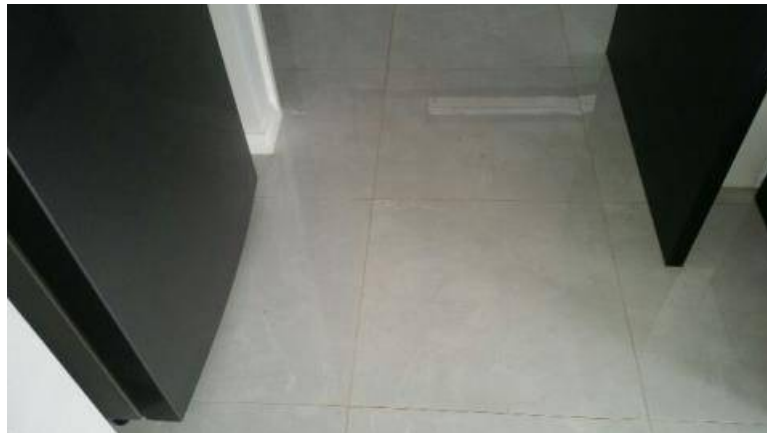
The condition of the floors is generally fair. Floor tile joints are uneven and surface joints are not flush, rectification is required for an acceptable finish.

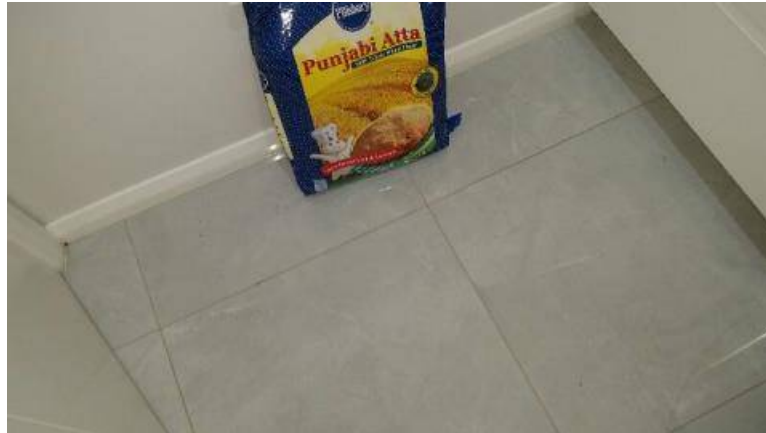
The condition of the floors is generally fair. Floor tile joints are uneven and surface joints are not flush, rectification is required for an acceptable finish. (See General Section of the Report)

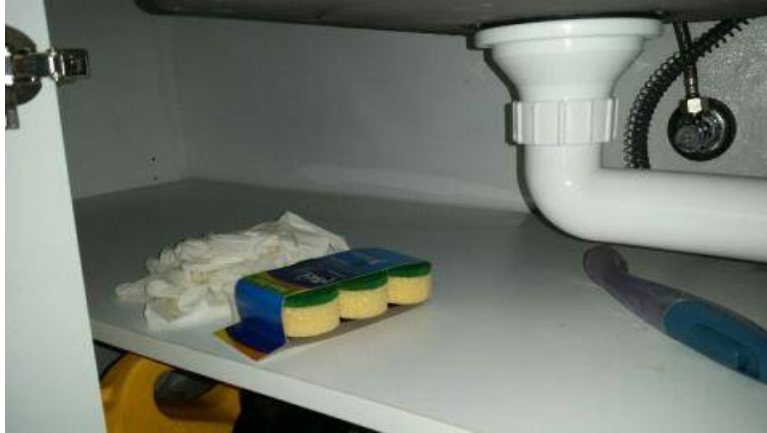
The cabinets appear to be in a serviceable condition. The taps appear to be in a serviceable condition. Some leakage was noted at the drain.

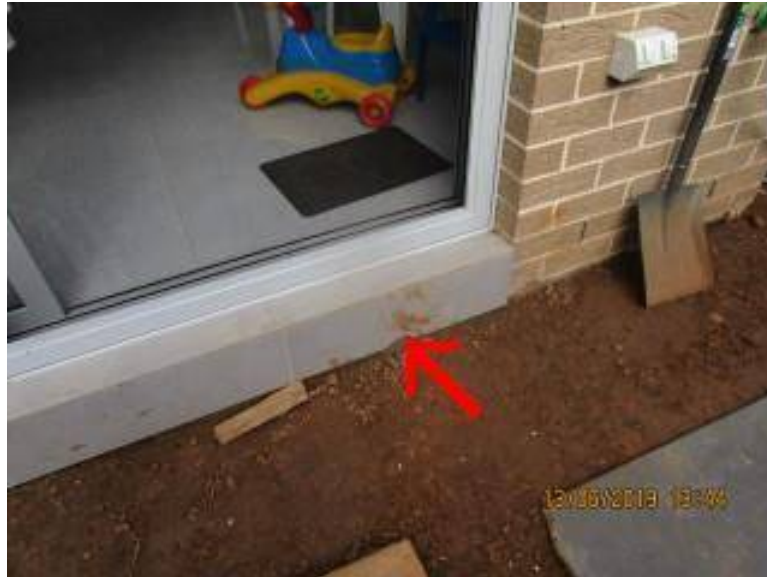
The condition of the exterior of the windows is generally fair. Impact damage was noted to window glass panel to kitchen, recommend rectification. Damaged threshold tile should be replaced for an acceptable finish.

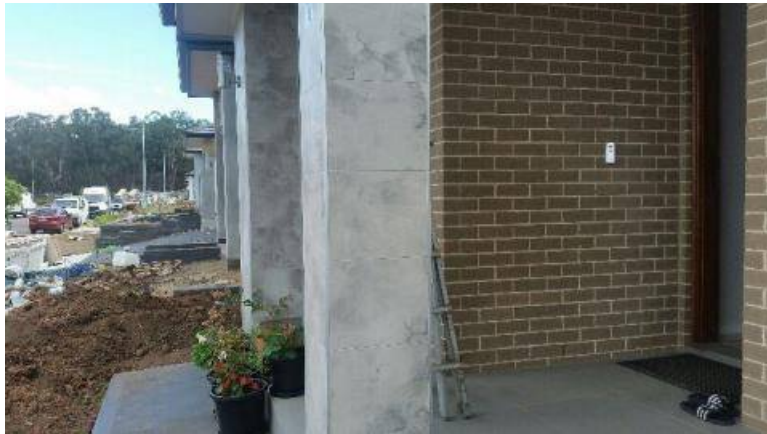
The drummy floor tiles to column and will require repair.

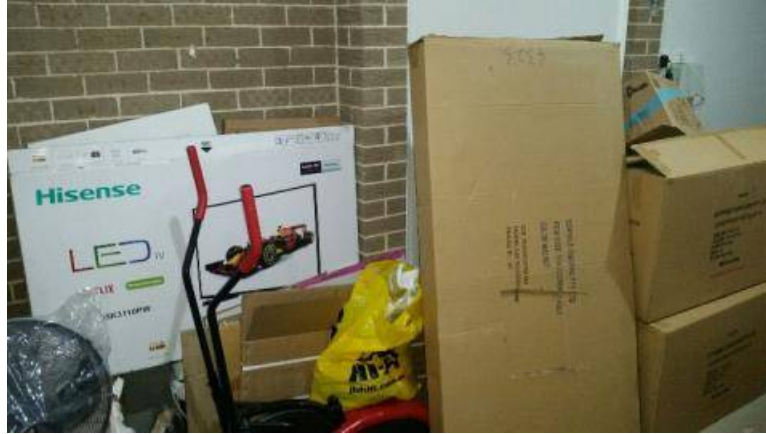
Stored items restricted inspection to the interior. Stored items should be removed to enable a more complete report to be submitted.

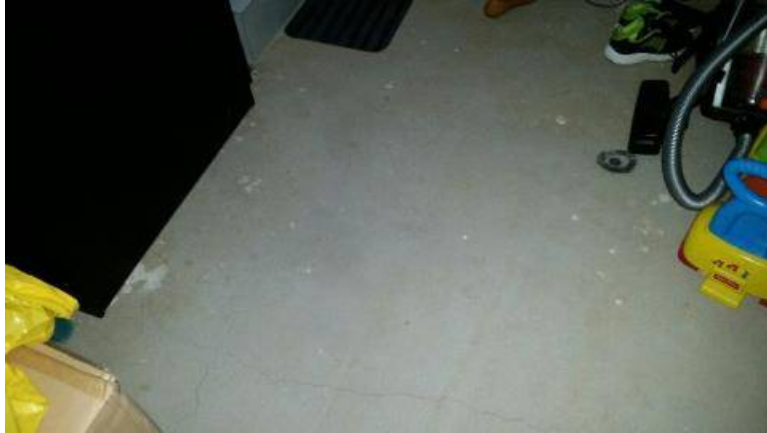
Cracks are evident. Visible cracking has been categorized as an appearance defect. Cracking of a building element is an appearance defect where in the opinion of the inspector the appearance defect is blemished, however, the expected consequence of the cracking is unknown until further information is obtained.

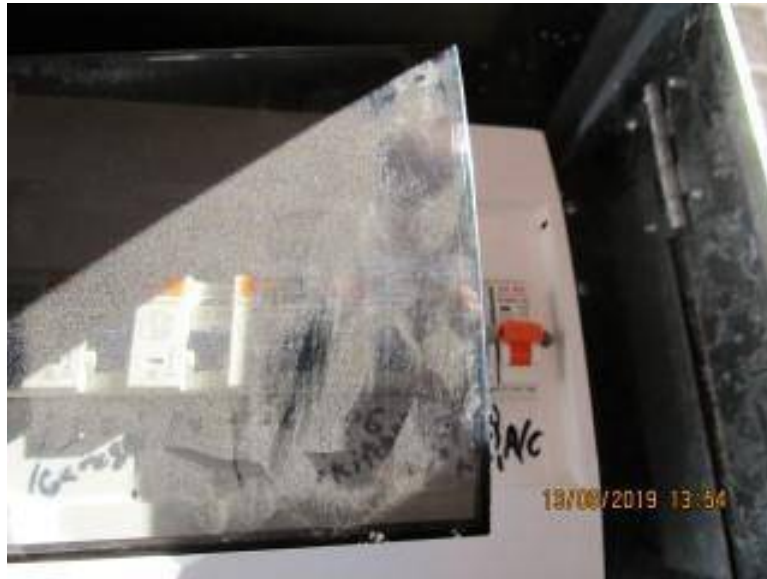
Gas is connected to the premises but has not been inspected. The cold water was operational but the adequacy was not tested and is not commented on. Smoke detectors are fitted however, the positioning, operation or adequacy was not tested and is not commented on. Air-conditioning is installed in the premises but has not been inspected. An alarm system is present, however, the operation or adequacy was not tested.

Circuit breaker cover is damaged, recommend replacement.
