Pre-Purchase Timber Pest Inspection Report

(In accordance with Australian Standard 4349.3 - 2010)

VISUAL TIMBER PEST INSPECTION REPORT as per AS4349.3-2010

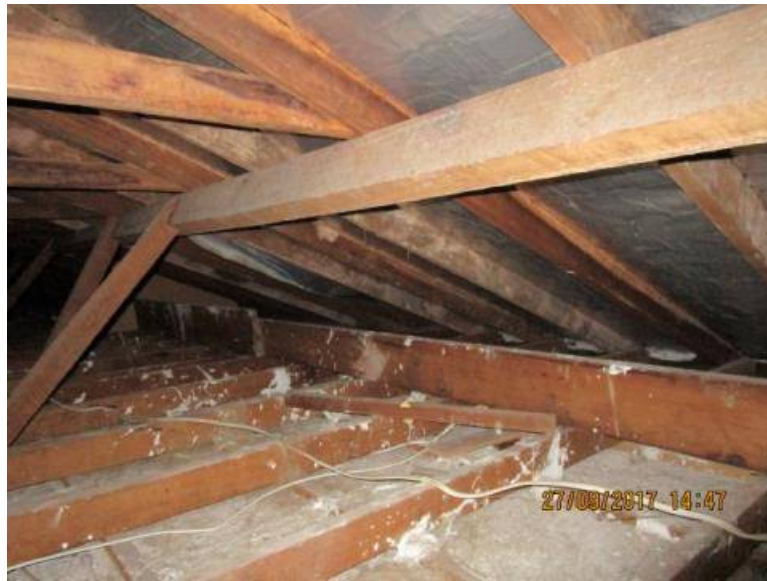
Inspection Restrictions

Inspection over the eaves was restricted due to the low pitch and construction allowing only a limited visual inspection from a distance to be carried out. Insulation is present in the roof cavity. This restricted inspection to some roofing timbers. Removal of insulation is not within the scope of a standard visual timber pest inspection report however, this would be necessary for a more complete report to be submitted. Sarking paper covered tile battens restricting inspection.

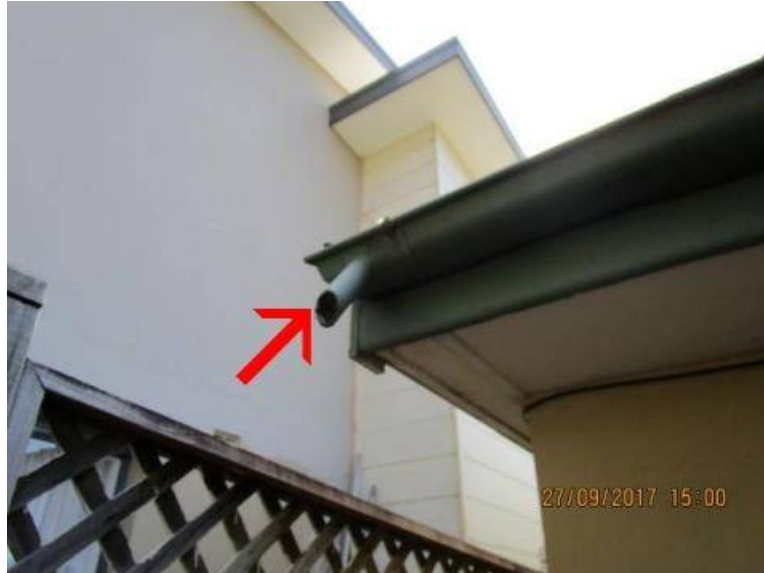
Some gutters and/or downpipes appear to discharge rainwater directly adjacent to the foundations of the structure. These should be connected to a stormwater dispersal system.

The hot water system overflow is discharging moisture adjacent to the structure. Hot water units that release water alongside or near to building walls should be piped to a drain (if not possible then several meters away from the building) as the resulting wet area is highly conducive to termites.

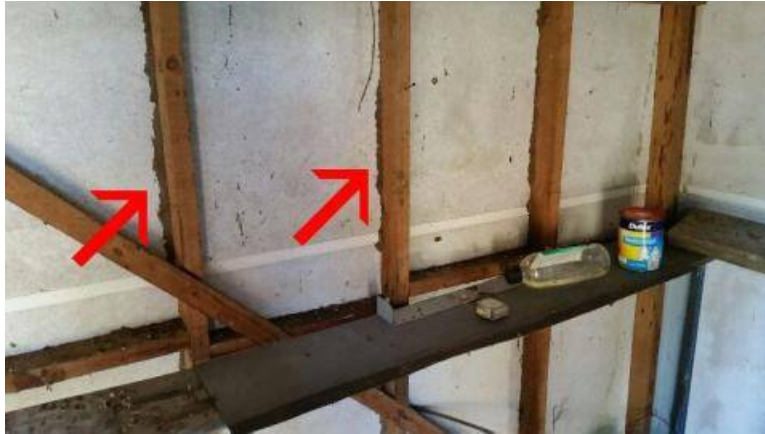
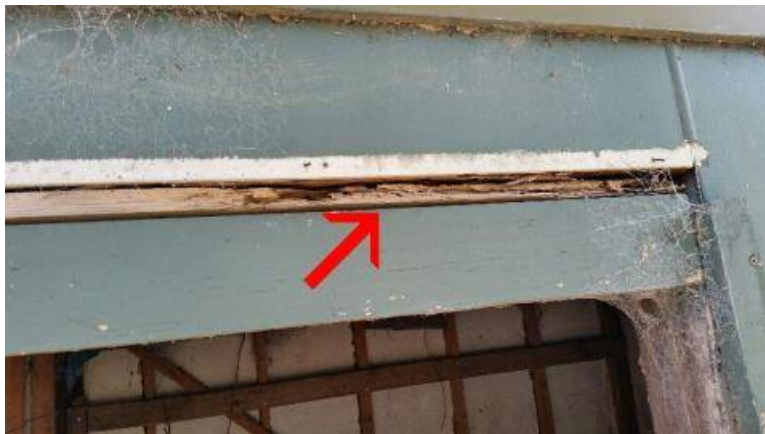
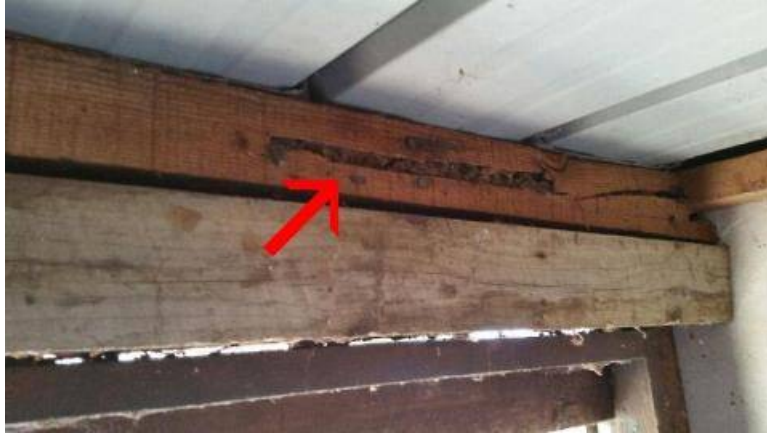
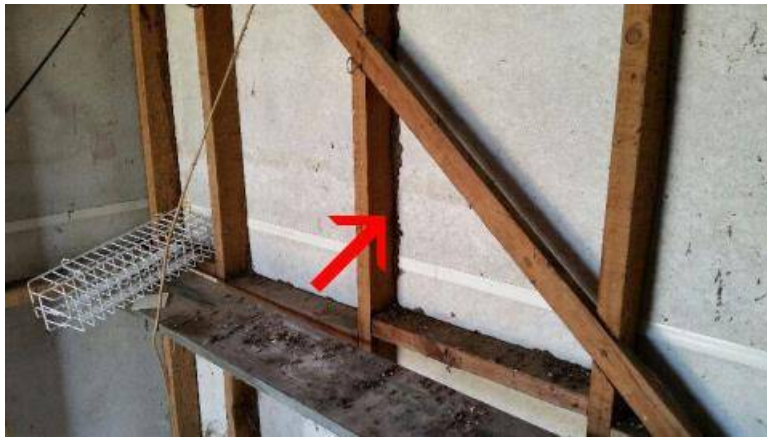
Yes - Inspection revealed currently inactive termite attack (damaged timbers and/or termite workings) within this area including but not necessarily limited to the following timbers and the areas listed below. Also refer to section 5.0 (Evidence of Termite Damage) at the end of this report.

Affected outbuilding timbers

Framing timbers: Various external timbers.

Visible timber damage appears moderate to severe, repairs will be required. Refer to the definitions section of this report - Section 1.6 - Timber Damage.
